# TECHNICAL REPORT IN-033/2022

Incident on 4 June 2022 involving a BOEING 737-800 aircraft operated by Ryanair, on registration EI-GJS, and an AIRBUS A-300 aircraft operated by DHL, on registration D-AEAO, at Josep Tarradellas Barcelona - El Prat Airport (Barcelona, Spain)

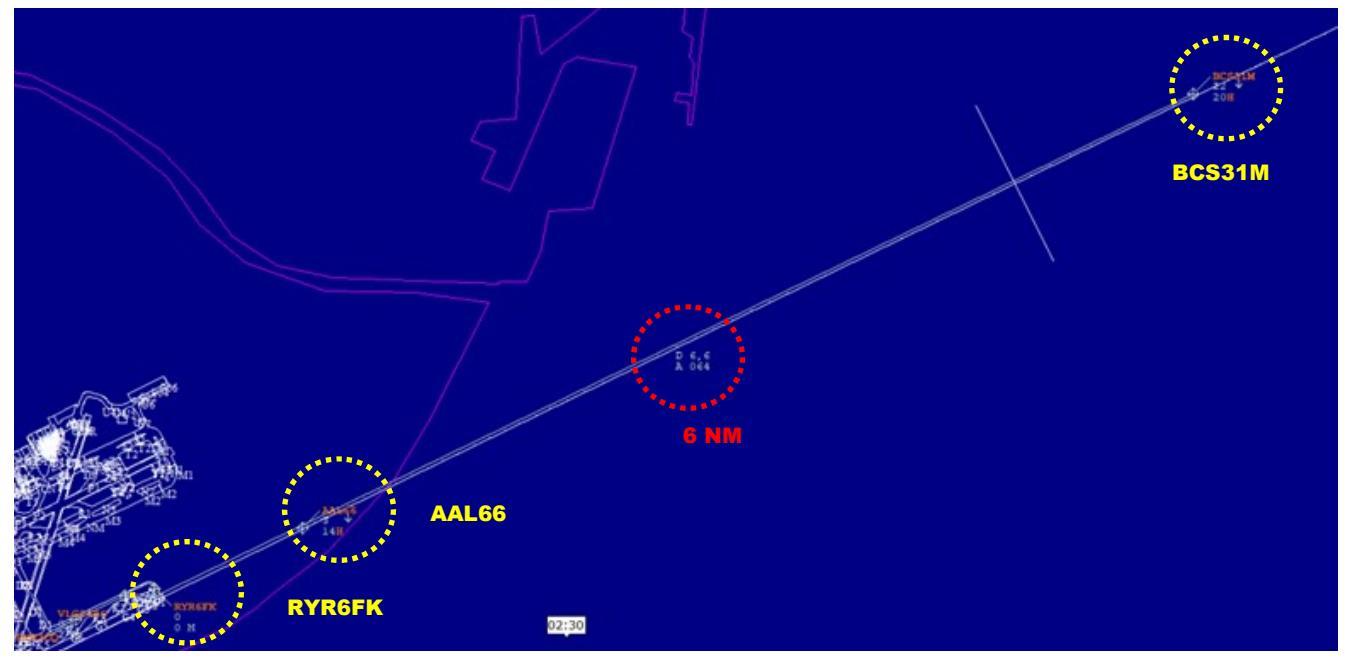
Figure 1. Positions of the aircraft at 6:30:13 h

At 6:29:02 h, the crew of the BOEING 737-800 with registration number EI-GJS and call sign RYR6FK informed the tower (TWR LCL 24L) that they were ready for departure. At 6:30:13 h, TWR LCL 24L asked if they had sight of the aircraft with call sign AAL66 on short final and the reply from the BOEING crew was affirmative.

At this point, the next aircraft on approach, the AIRBUS A-300-600 aircraft with registration D-AEAO and call sign BCS31M, was on final at 6.6 NM, behind the AAL66 aircraft and descending through 2,200 ft.

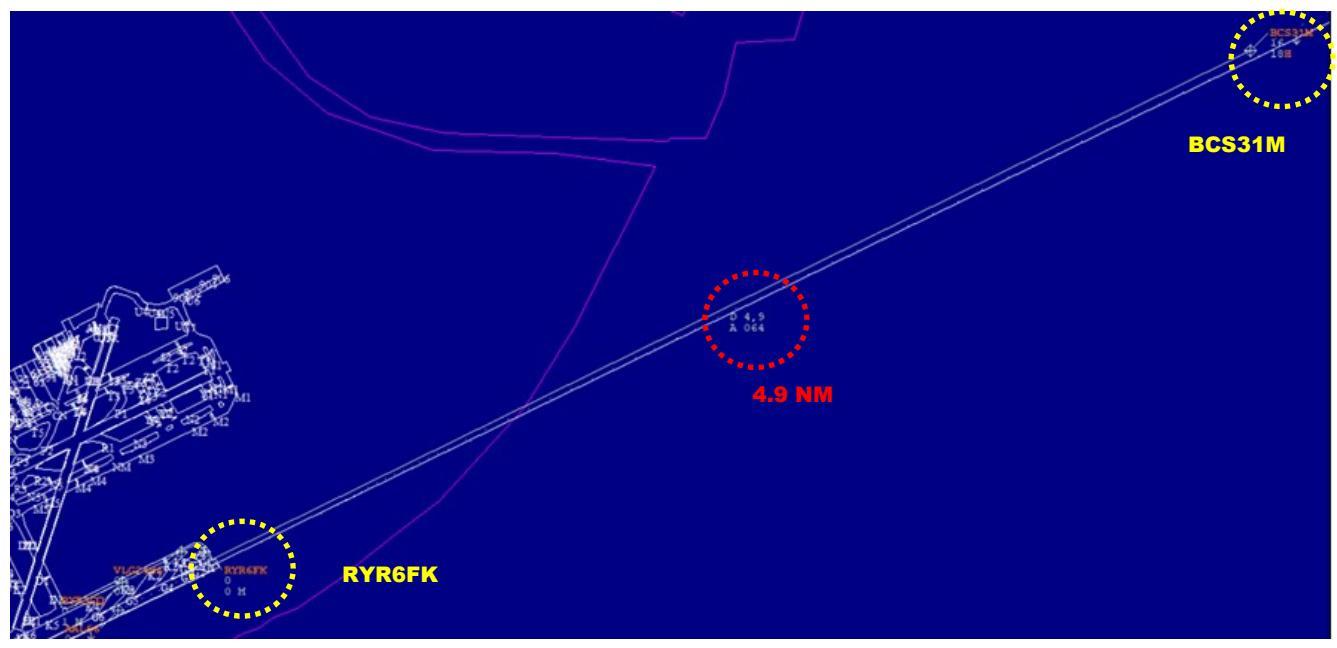
Figure 2. Positions of the aircraft at 6:30:46 h

At 6:30:46 h, the RADAR trace shows the RYR6FK aircraft lined up on the runway and the BCS31M aircraft at 4.9 NM on final for the same runway and descending through 1,600 ft.

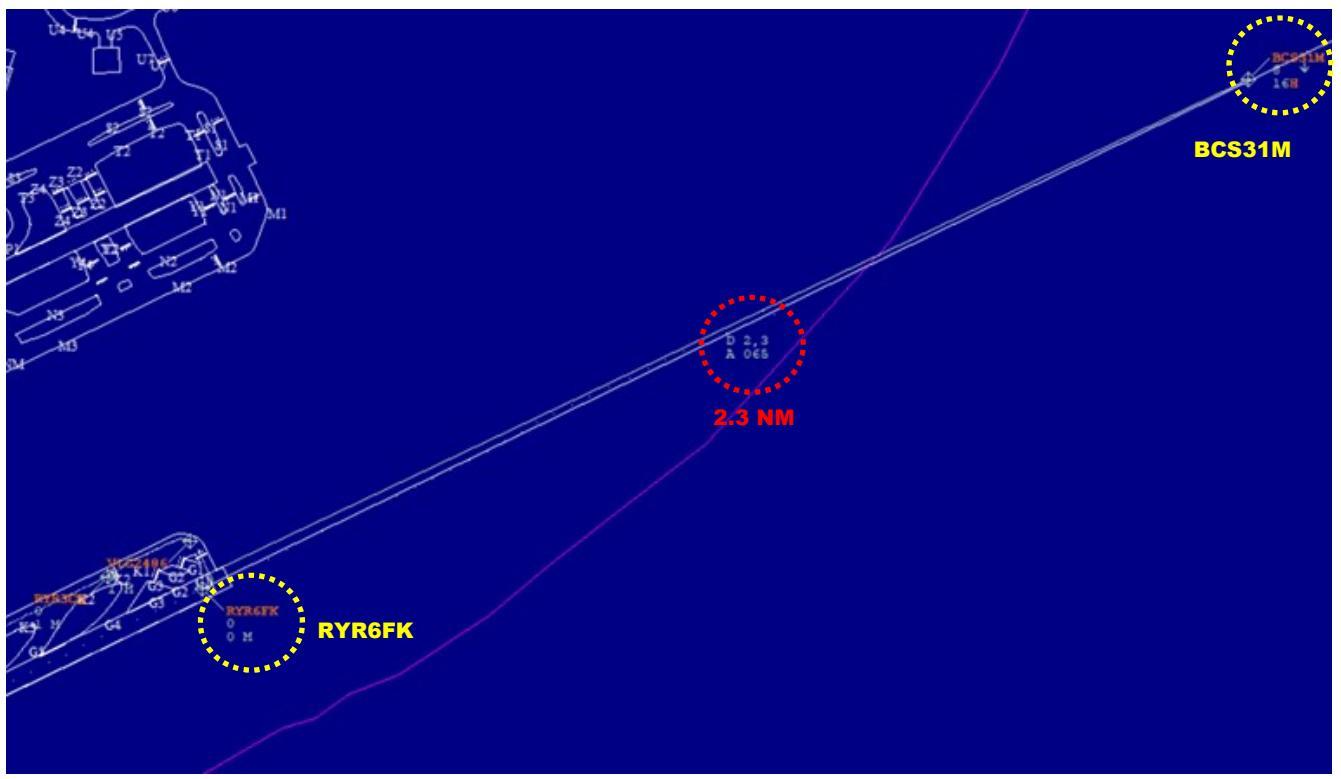
Figure 3. Positions of the aircraft at 6:31:44 h

At 6:31:44 h, the RYR6FK aircraft lined up on runway 24L was cleared for take-off while the BCS31M aircraft had reached 2.3 NM on final and was descending through 800 ft, its minimum altitude during its approach.

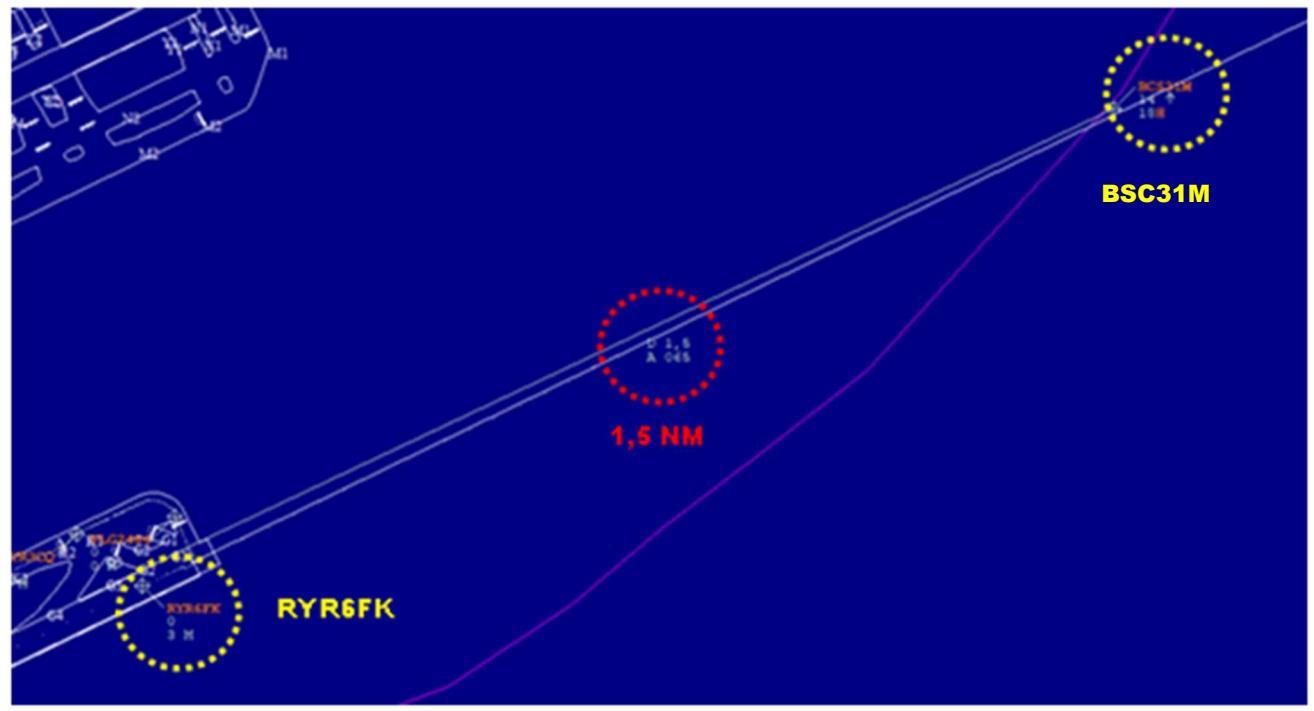
Figure 4. Positions of the aircraft at 6:31:59 h

At 6:31:58 h, the BOEING aircraft with call sign RYR6FK commenced its take-off run. The aircraft executing the missed approach was 1.5 NM behind the threshold, climbing through 1,400 ft.

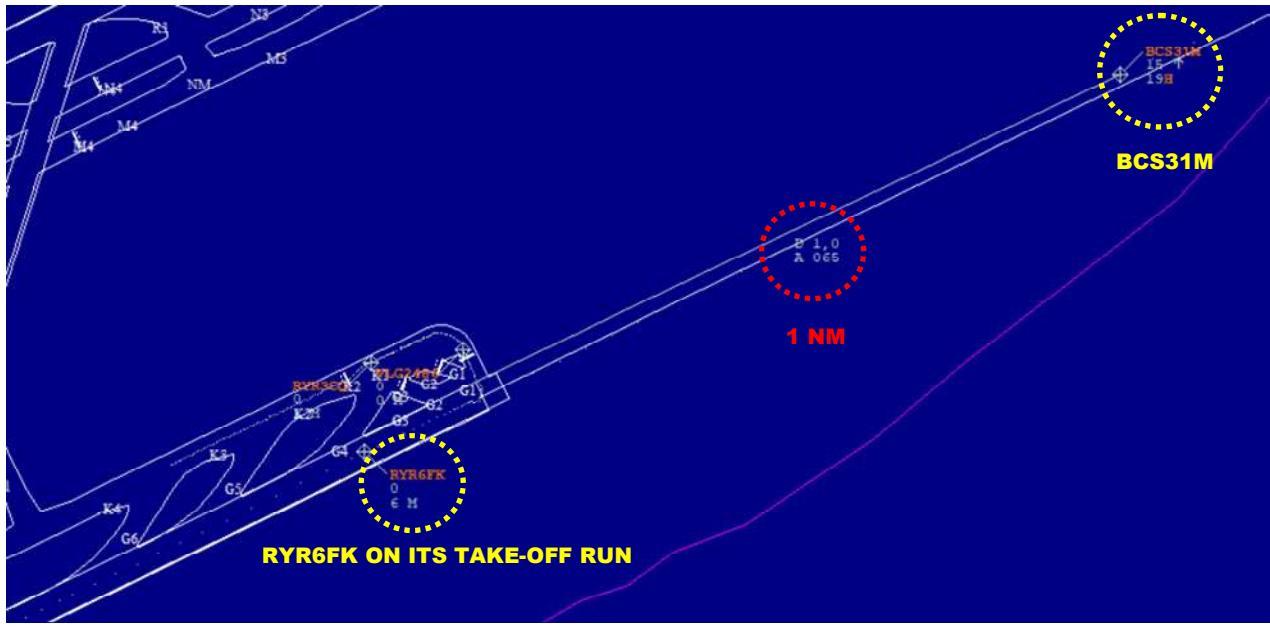
Figure 5. Positions of the aircraft at 6:32:06 h

At 6:32:06 h, the RADAR trace shows the BCS31M aircraft reaching 1,500 ft at 1 NM from the end of runway 24L, which is the standard altitude in this missed approach zone.

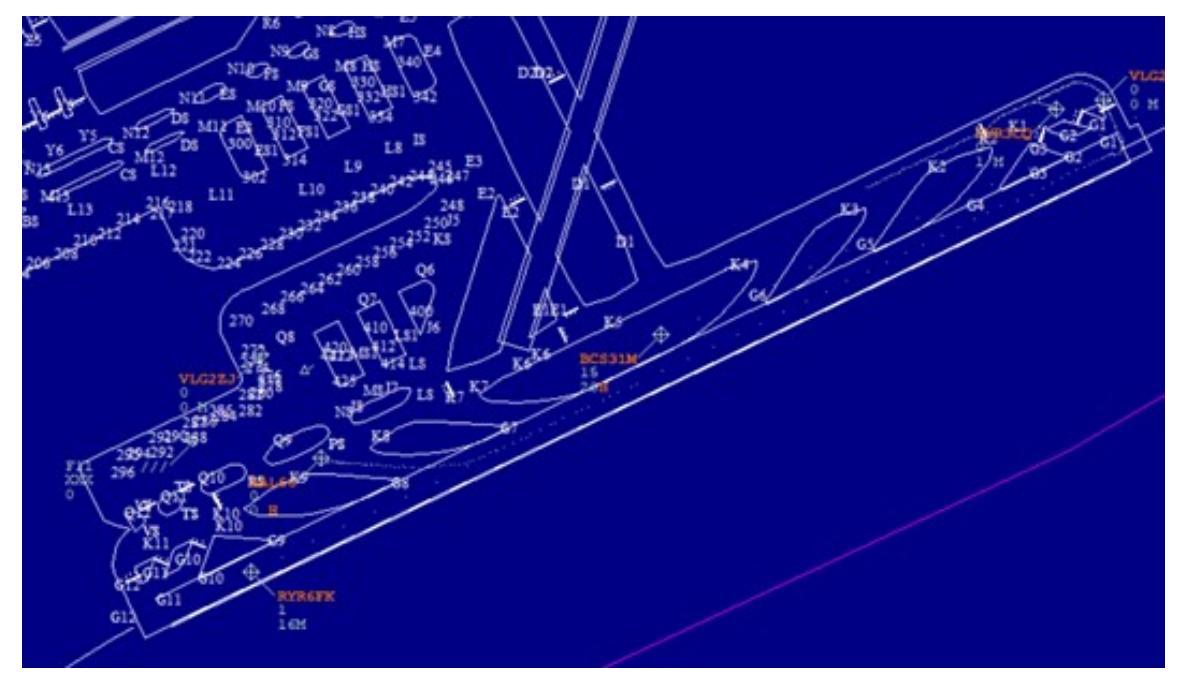
Figure 6. Positions of the aircraft at 6:32:36 h

At 6:32:36 h, the RADAR trace shows the aircraft with call sign RYR6FK climbing through 100 ft and the aircraft with call sign BCS31M flying over runway 24L, maintaining 1,500 ft.

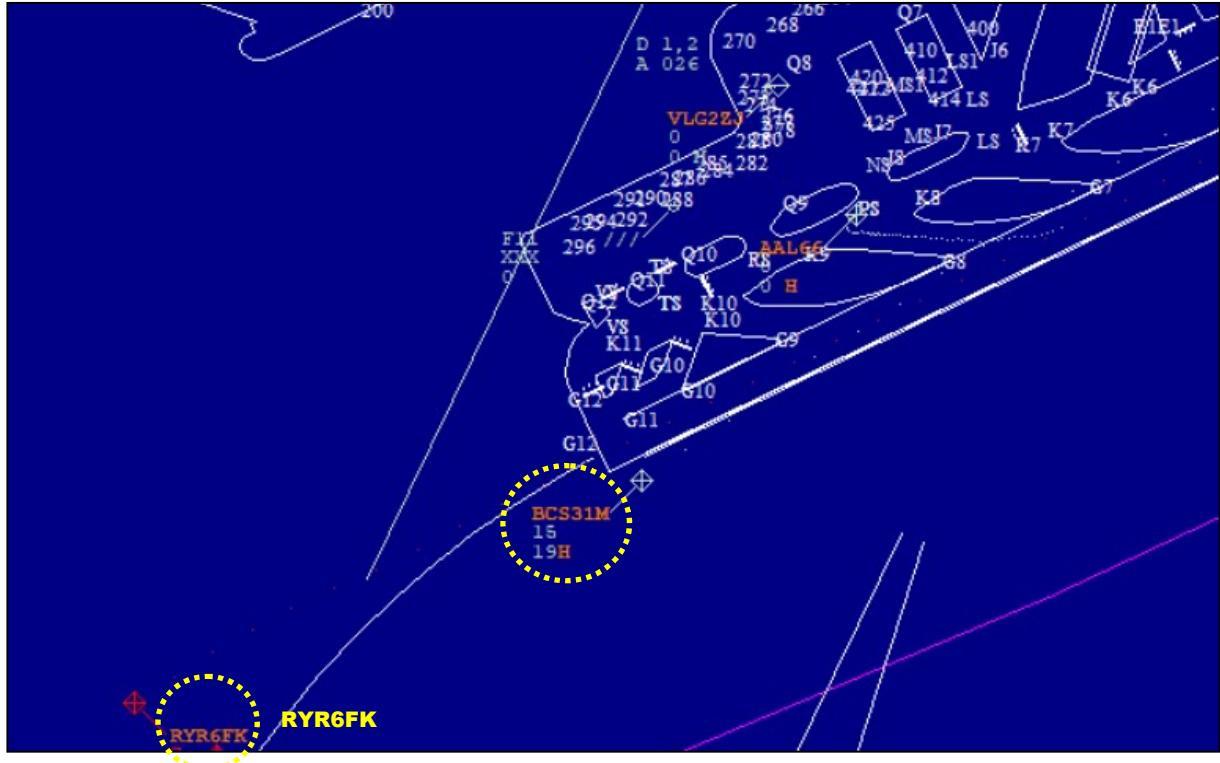
Figure 7. Positions of the aircraft at 6:32:51 h

At 6:32:51 h, the RADAR trace shows the RYR6FK aircraft climbing through 700 ft and the BCS31M aircraft behind it maintaining 1,500 ft.

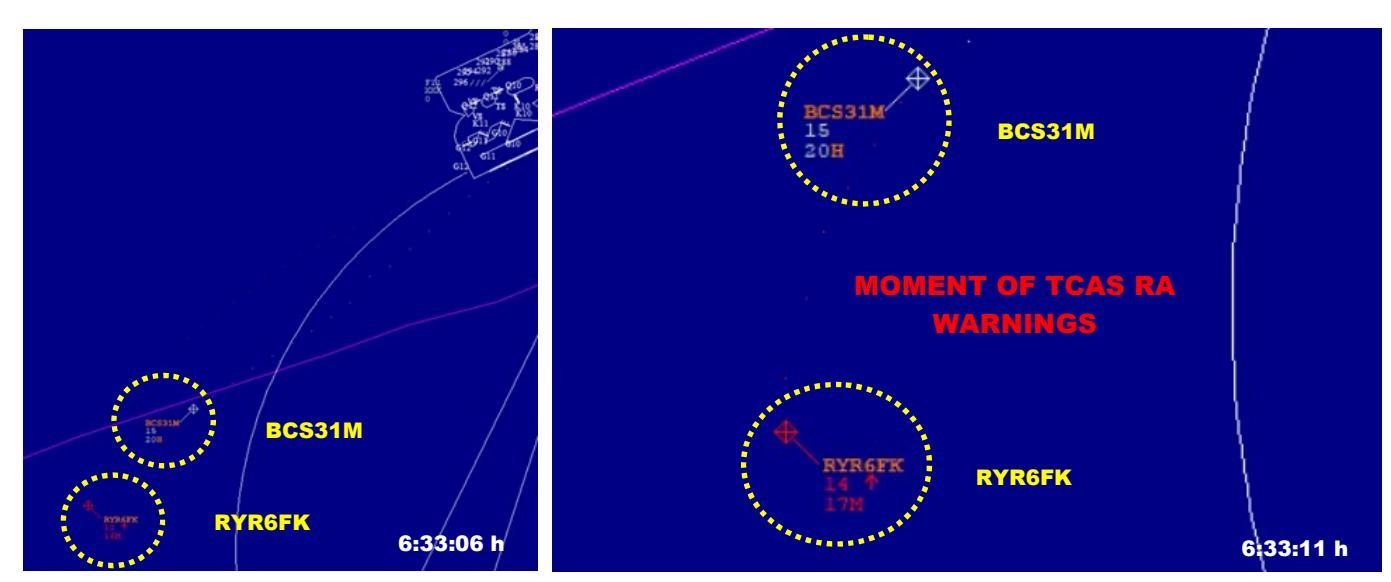
Figure 8. Positions of the aircraft at 6:33:06 h and 6:33:11 h

At 6:33:06 h, the controller on the local frequency (TWR LCL 24L) transferred the aircraft with call sign RYR6FK to the approach controller (APP LECB), and the RADAR trace shows it climbing through 1,200 ft cleared to 2,000 ft. The BCS21M aircraft is shown maintaining 1,500 ft. Five (5) s later (6:33:11 h), the aircraft with call sign RYR6FK was climbing through 1,400 ft and cleared to 2,000 ft, and the aircraft with call sign BCS31M was still holding at 1,500 ft. This was when the two aircraft were closest, separated by 0.3 NM horizontally and 200 ft vertically, triggering their TCAS RA warnings.

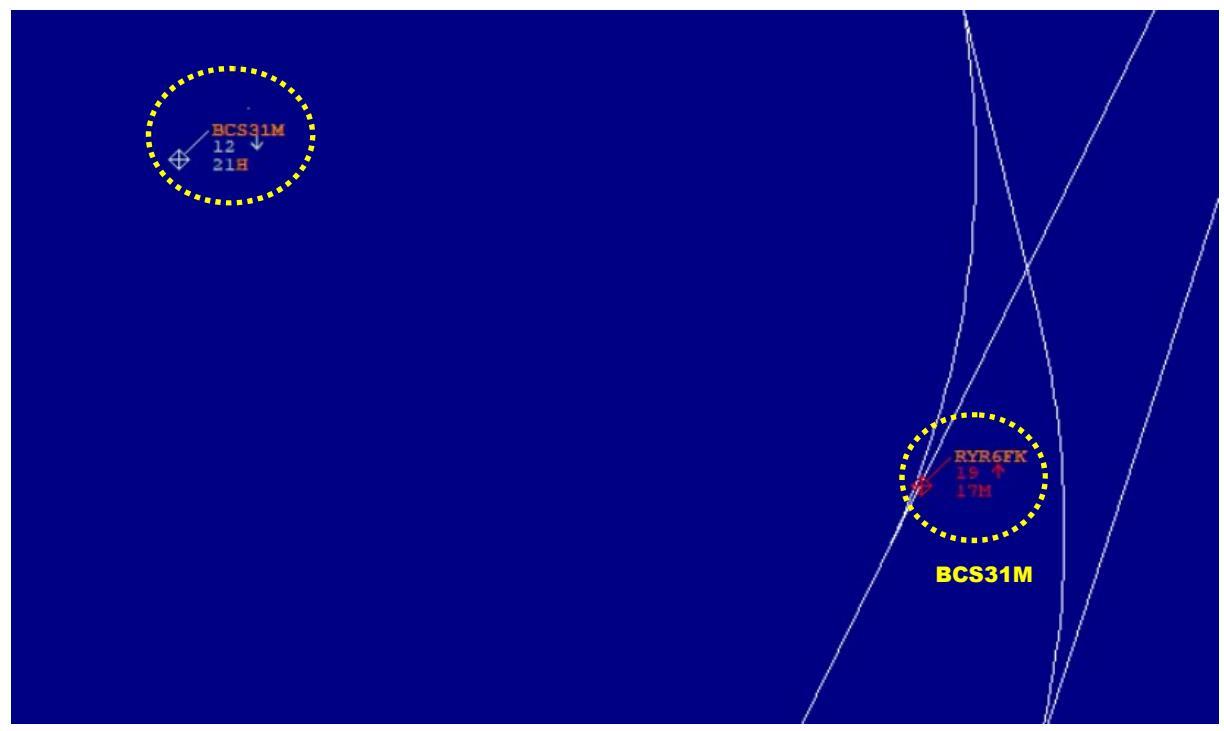
Figure 9. Positions of the aircraft at 06:33:30 h

At 6:33:30 h, the aircraft with call sign BCS31M notified TWR LCL 24L that it had received a TCAS RA warning, and after a request for confirmation by TWR LCL 24L, that they were climbing to 3,000 ft flying the standard missed approach procedure. The RADAR trace shows the aircraft with call sign RYR6FK climbing through 1,500 ft and the aircraft with call sign BCS31M descending through 1,200 ft.

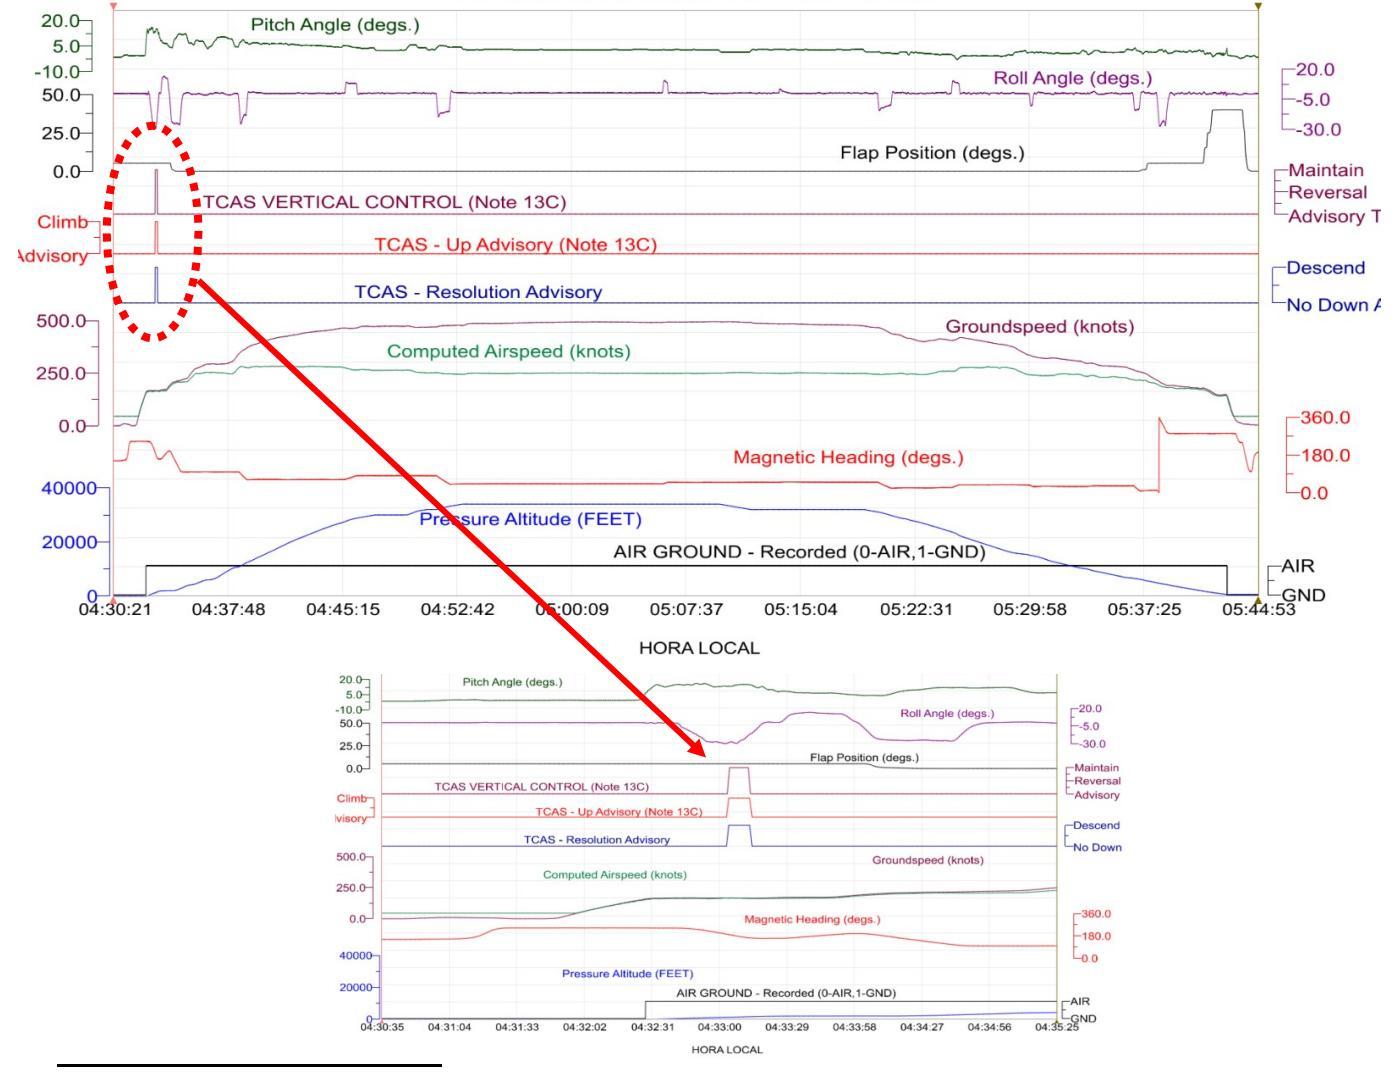
<sup>&</sup>lt;sup>6</sup> The time Figure 12, filight parameters recorded on the BOEING 737-800 aircraft

It was on a magnetic heading of 190.9 °, which varied to 164.85 ° during the 9 s that the warning remained in force.

The flaps were deployed at an angle of  $5.3^{\circ}$ , varying the pitch angle between  $13^{\circ}$  and  $14.5^{\circ}$ , while the roll angle ranged between  $-26.5^{\circ}$  and  $-16^{\circ}$  (to the left).

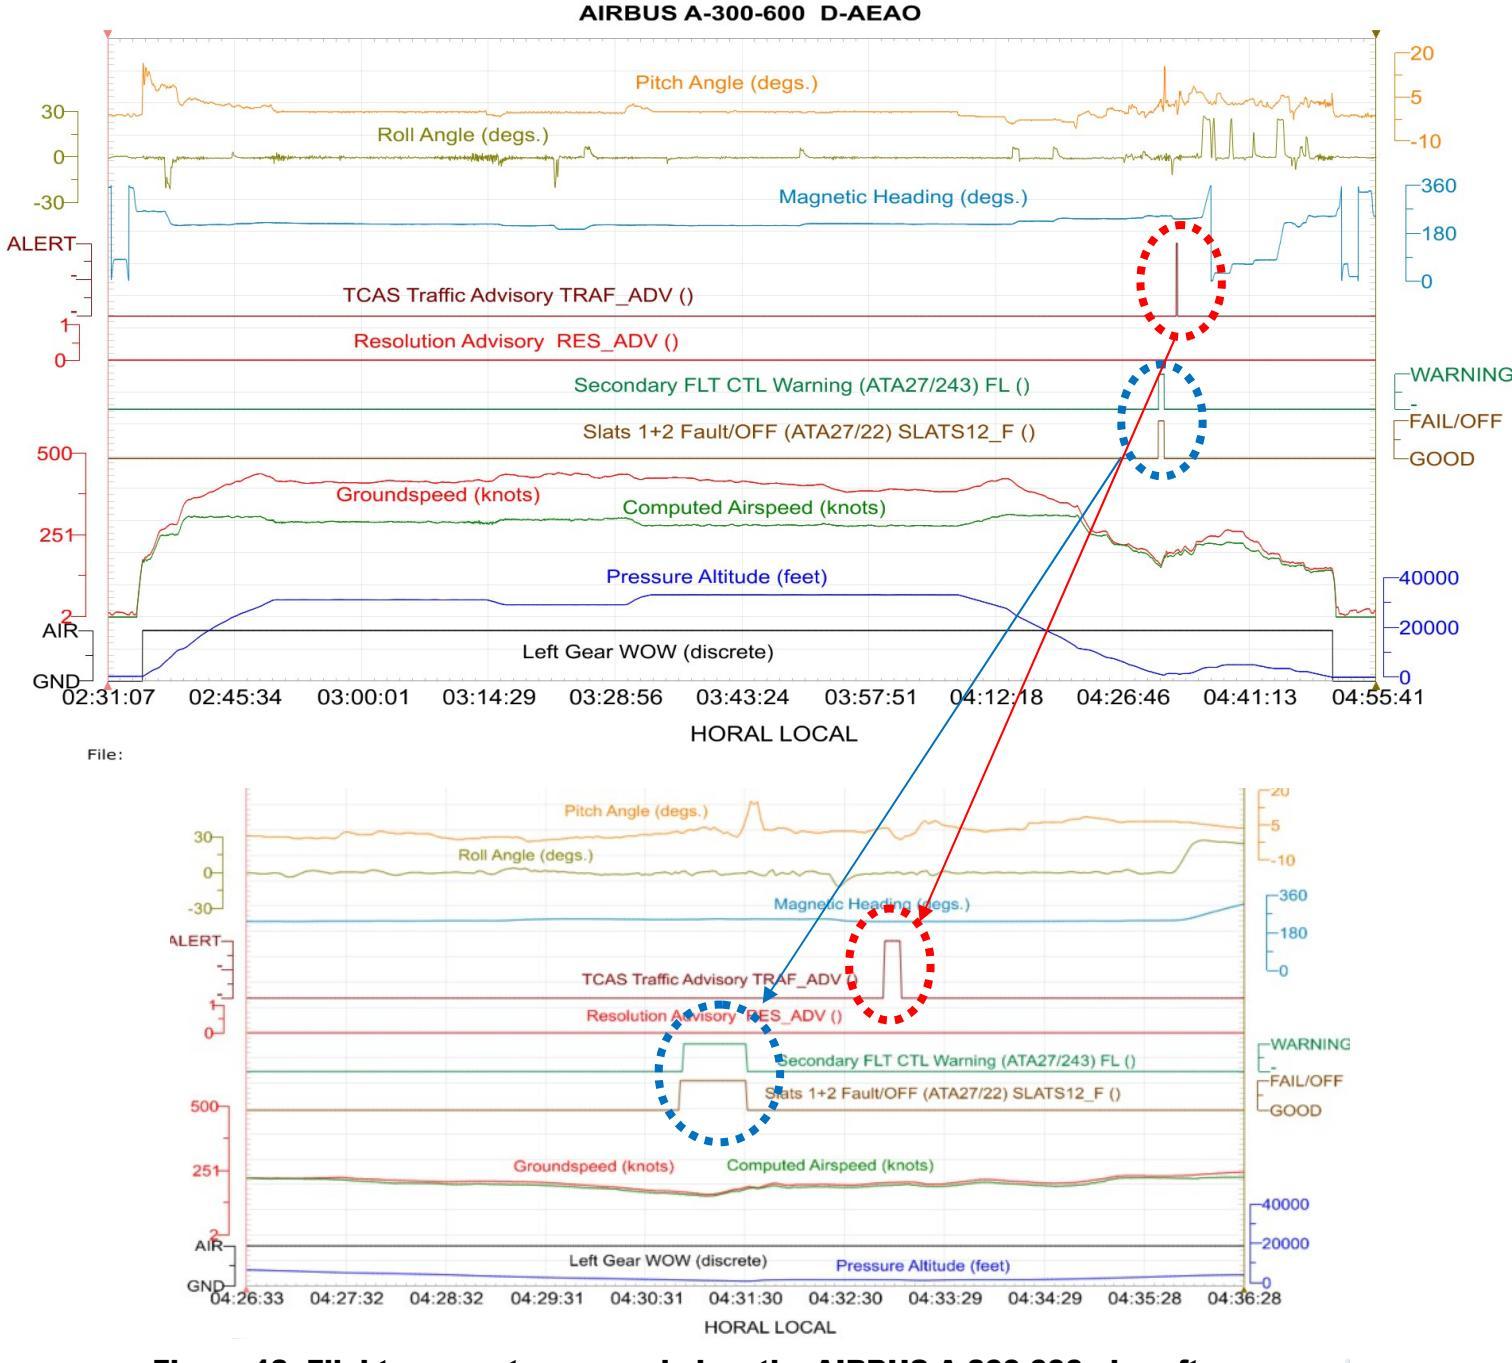
Figure 13. Flight parameters recorded on the AIRBUS A 300-600 aircraft

It was on a magnetic heading of 233 °, which it maintained for the duration of the warning, and the flaps were not deployed. The pitch angle was 4 °, and it was level, i.e. not rolling.

The aircraft maintained an altitude of 1,500 ft along the along the length of the runway centreline and began turning left.
