# TECHNICAL REPORT IN-033/2022

Incident on 4 June 2022 involving a BOEING 737-800 aircraft operated by Ryanair, on registration EI-GJS, and an AIRBUS A-300 aircraft operated by DHL, on registration D-AEAO, at Josep Tarradellas Barcelona - El Prat Airport (Barcelona, Spain)

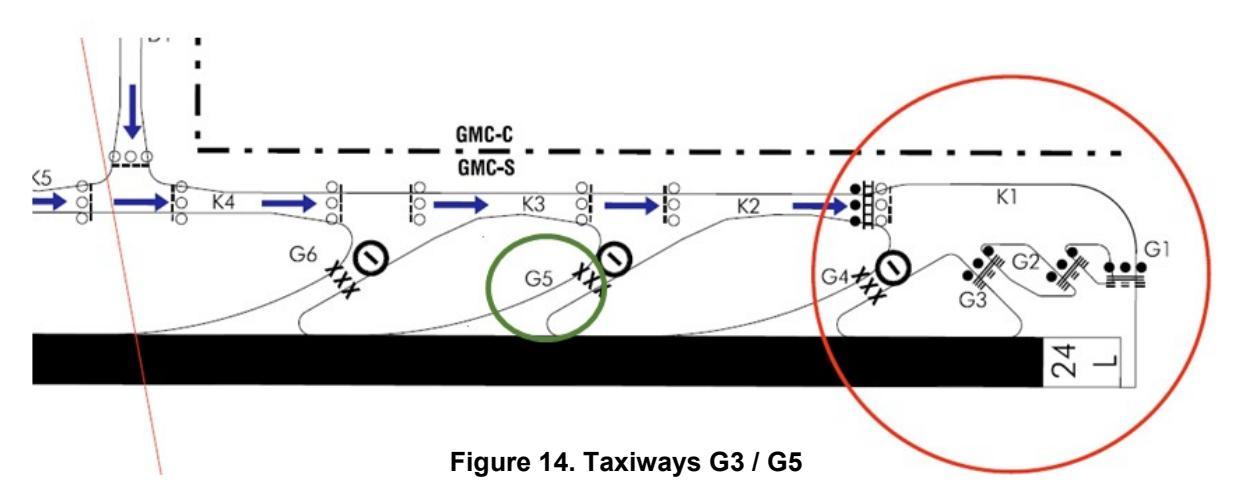
The airport was operating in phase 2 of the reduced visibility procedure (cloud base 500 ft and 7,000 m visibility), and the crew of the BOEING 737-800 (RYR61FK) were cleared for take-off between two heavy turbulent wake aircraft (one had just landed and the other was at 2.4 NM). When the AIRBUS A 300-600 (BCS31M) reached 1.9 NM on final, its crew were instructed to wait for a late clearance, and it was during this communication that the controller was advised the aircraft was executing a missed approach. At that point, the BOEING 737-800 (RYR61FK) had yet to cross G3 and was taxiing at just 20 kt. It took a few moments to request confirmation of the missed approach from the AIRBUS A 300-600 (BCS31M). When their reply was received, the BOEING 737-800 (RYR61FK) was passing G5 at a speed of 60 kt, and its take-off was allowed to proceed. Given the unusual situation, this was not an appropriate decision; therefore, the planning is considered to have been inadequate.

- After the BOEING 737-800 (RYR61FK) aircraft took off, control failed to provide traffic information to the AIRBUS A 300-600 (BCS31M) crew, which, given that the minimum separation reference used in single-runway operations is the length of the runway, was essential for them to ensure the appropriate separation in their trajectory.
